Implications of the reduction of cutting fluid in drilling AISI P20 steel with carbide tools

Rodrigo P. Zeilmann · Gerson L. Nicola · Tiago Vacaro ·
Cleiton R. Teixeira · Roland Heiler

Keywords Machining · Drilling process · Cutting tools · Wear · Surface analysis

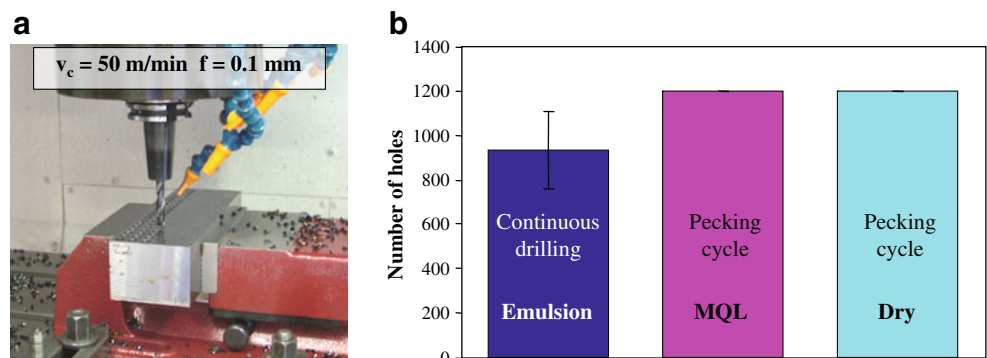
facilitate the expulsion of the chips from the hole. Therefore, it was adopted as the pecking cycle with an advance of 1.5 mm followed by a retreat out of the hole. The retreat improved the chip expulsion from the hole, and in this way, the microchippings at the margins no longer occurred. However, this strategy increased the drilling time by about 150%. To compensate part of this loss of productivity, tests were made with the cutting speed of 50 m min^{-1} , which showed similar results to those obtained with 40 m min^{-1} . Thus, for the main experiment, the cutting speed of 50 m min^{-1} was adopted, and the pecking cycle for MQL and dry conditions was used. For processing with the emulsion, the tests were performed by continuous drilling in order to attain lower cutting times. With these definitions, the main experiment was carried out, and the results are presented below. Figure 9 presents the wear results from the experiments with $v_c=50 \text{ m min}^{-1}$.

Drilling with the emulsion gave the worst result and the tools made 933 holes on average. For MQL tests, all three tools made 1,200 holes, but only one reached the end of tool life. For the other two, the test was interrupted by the criterion of 1,200 holes drilled. The dry drilling experiments presented the best results, because all tests were interrupted by the 1,200 holes criterion.

Fig. 9 Picture of the drilling process (a) and wear results expressed in terms of the number of holes drilled (b)

The worst results for the emulsion tests can be explained by the cooling of the machined material. The presence of the cutting fluid removes the positive effect of the heat in the cutting zone, which facilitates the material shear (lower resistance to cutting). That way, the cooled material presents greater strength, increasing the mechanical loads on the tool and, consequently, the tool wear. In the emulsion tests, also a high adhesion of material on the flank of the tools was observed, which leads to microchipping and tool failure. Figure 10 shows the material adhesion and the consequent microchipping.

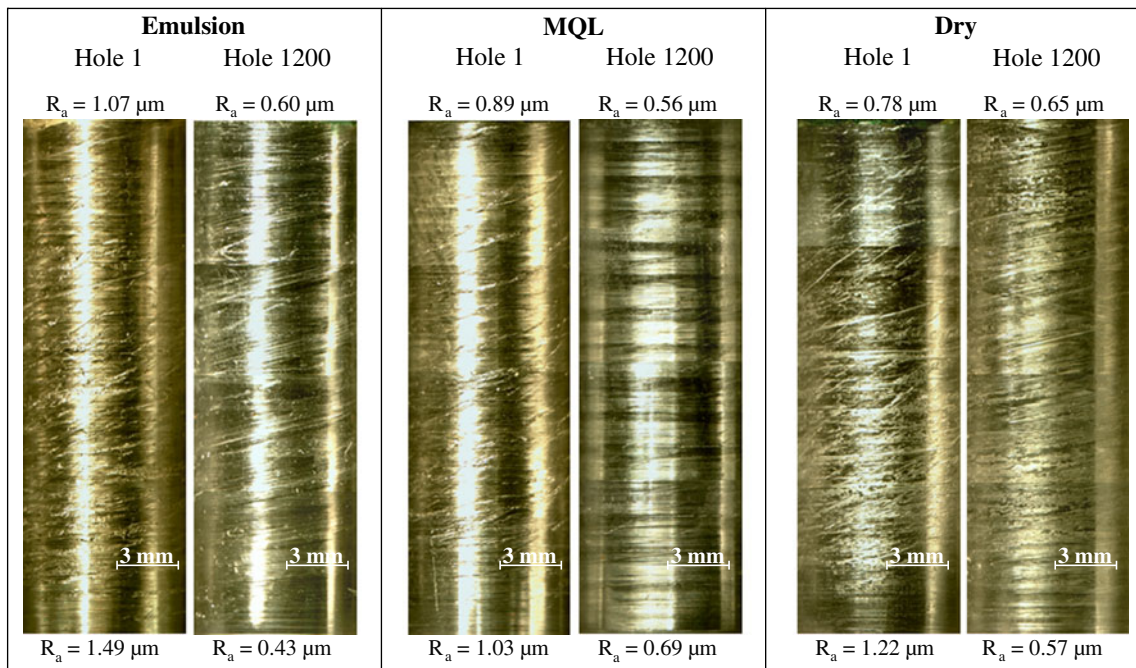
roughness [33]. Figure 12 shows the surface texture of the first and last holes for the different fluid application conditions.

For drilling with the emulsion, the marks of the passage of the cutting edge can be seen, and in the first hole, there are deeper grooves which result in greater roughness values than in the last hole. The holes drilled with MQL presented a more homogeneous texture along the holes, especially in the last hole. For the MQL condition, the microlubrication associated with the facilitated material shear due to the temperature increase in the cutting zone reduces the cutting forces and allows the formation of a smooth surface. The holes obtained by dry drilling presented the worst visual aspect, with evidence of material adhesion along the holes and a smoothed surface in the final region of the holes, probably due to the occurrence of microwelding.

Fig. 12 Surface texture of first and last holes for the different fluid application conditions

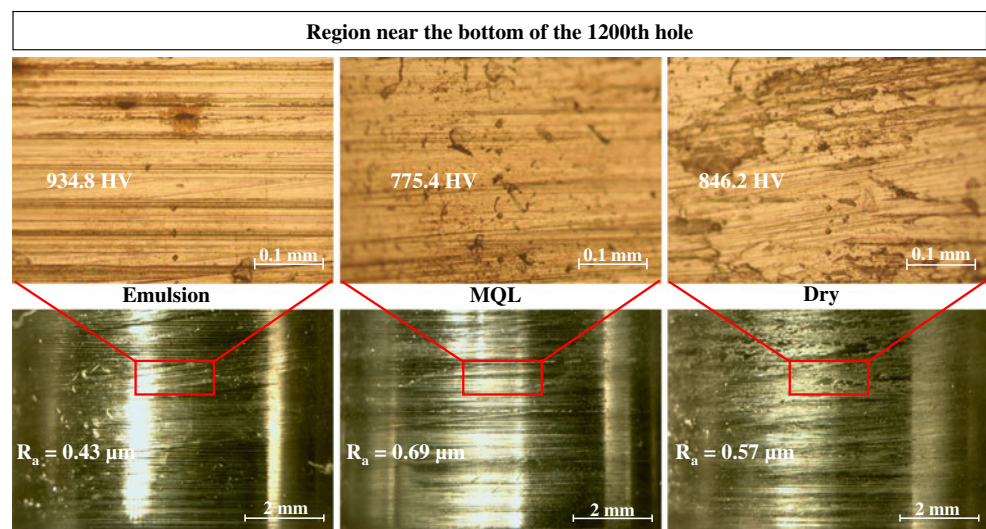
To complement this analysis, Fig. 13 illustrates the surface texture of the region near the bottom of the 1,200th hole with a larger zoom and also shows the average value of the microhardness measured on the surface of the hole for each condition. The measured values are approximately twice as large as the bulk material hardness, 390 HV on average. These results corroborate the hypothesis of the occurrence of microwelding, since the welded chip tends to be submitted to high thermal and mechanical loads, which can lead to the microhardening of the chip.

Fig. 13 Surface texture in the region near the bottom of the last holes

The microhardness measurements on the surface of the last holes, in the region near the bottom, resulted in values approximately twice as large as the bulk material hardness, which corroborates the hypothesis of the occurrence of microwelding, because applying high thermal and mechanical loads to the welded chip causes microhardening of the chip.

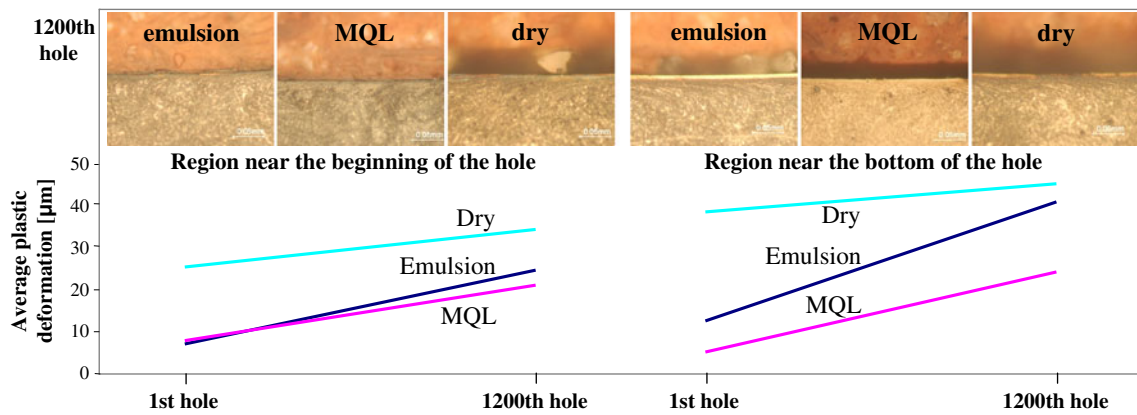
Figure 14 presents the values of the plastic deformation measured near the beginning and the bottom of the first and

last machined holes. Each value plotted in the graphs is the average value of the five maximum plastic deformations found in the analyzed region. The figure also shows metallographic images of the last hole surface for the different conditions tested.

For both analyzed regions (near the beginning and near the bottom), the measured deformation values were larger with the increase in the number of drilled holes due to the changed cutting edge geometry; this tends to increase the temperature in the cutting zone and, in turn, leads to the occurrence of higher deformations. It can also be observed that the measurements made near the bottom tend to be greater than those made near the beginning of the holes.

Fig. 14 Average plastic deformation measured near the beginning and near the bottom of the holes

This can be related to the greater difficulty of chip removal from the hole in the final region, increasing the contact between the chip and the piece, which causes the increase of heat generation and consequently higher deformation values.

Also, for the beginning and final regions, the dry tests resulted in greater plastic deformation, due to the process severity, because, as stated by the literature, this condition is characterized by higher maintenance of elevated temperatures in the cutting zone [6, 17–19]. Near the beginning of the holes, emulsion and MQL results were very similar, while near the bottom of the holes, the emulsion deformation results were larger. This difference is explained by the cutting strategy adopted for each condition. In the initial region, the fluid can reach the cutting zone for both conditions. However, in the final region, the continuous drilling employed in emulsion test impeded fluid access to the cutting zone, while in the MQL test, with the employment of the pecking cycle strategy, the edge receives a microlubrication after each retreat, which reduces the temperatures generated in cutting and results in lower deformations values.
